Microstructural investigation of IASCC crack tips extracted from thimble tube O-ring specimens

A. G. Penders^{a,b,1,*}, M. J. Konstantinović^a, T. Yang^{b,1,2}, R-W. Bosch^a, D.
Schryvers^{b,1}, F. Somville^c

The microstructural features of intergranular irradiation-assisted stress corrosion crack tips from a redeemed neutron-irradiated flux thimble tube (60 dpa) have been investigated using focused-ion beam analysis and (scanning) transmission electron microscopy. The current work presents a close examination of the deformation field and oxide assembly associated with intergranular cracking, in addition to the analysis of radiation-induced segregation at leading grain boundaries. Evidence of stress induced martensitic transformation extending from the crack tips is presented. Intergranular crack arrest is demonstrated on the account of the external tensile stress orientation, and as a consequence of MnS inclusion particles segregating close to the fractured grain boundary. Exclusive observations of grain boundary oxidation prior to the cracking are presented, which is in full-agreement with the internal oxidation model.

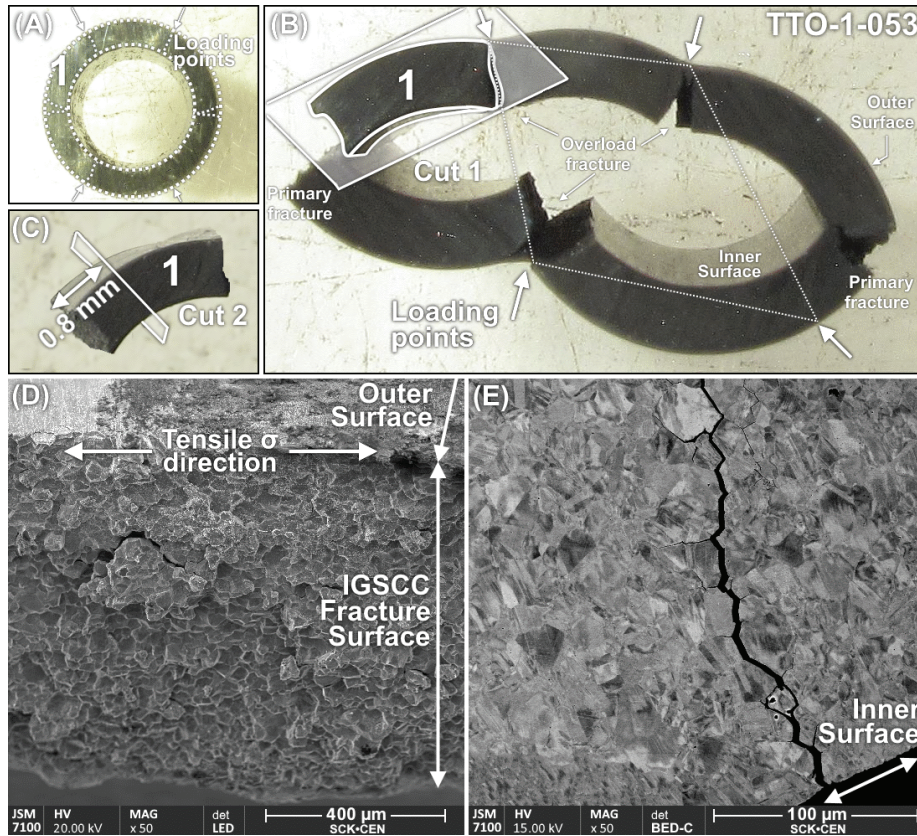
For the purpose of this study, a 60 dpa irradiated O-ring that failed into five majorly connected pieces post constant load testing was selected for microscopical analysis, see Fig. 1. The O-ring received the generic name TTO-1-053 and its testing parameters are presented in Tab. 2 and reference [38]. The specimen was chosen in view of the fact that both primary fracture surfaces post testing exhibited a full intergranular fracturing mode under scanning electron

Figure 1: TTO-1-053 sample preparation. (A) Intact O-ring specimen prior to constant load testing. (B) O-ring post constant load compression testing. Indications of the loading points and traversal cut along the middle of the specimen are depicted. (C) Second cut of the remaining piece, close to the primary fracture surface. (D) Secondary electron SEM view of the fracture surface illustrating the full intergranular mode. (E) Backscattered electron SEM view in edge-on orientation illustrating the extent of branched cracking from the inner surface.

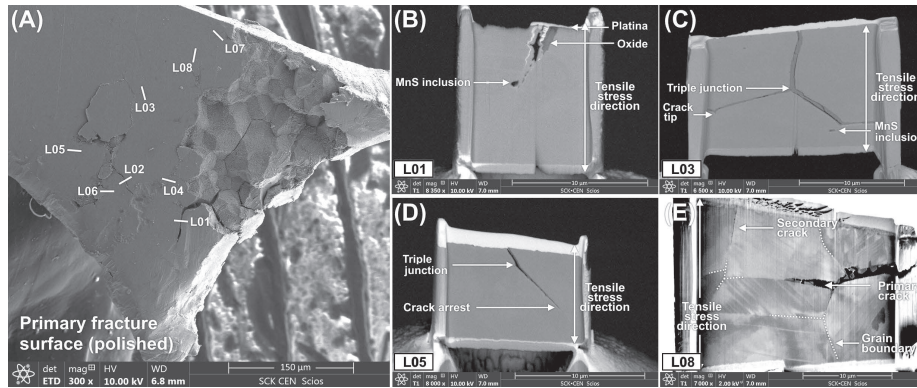
160 Ultimately, a single piece with a full intergranular fracture surface was retained for further investigation, considering that its fracture surface closely resembled an IASCC-like fracture appearance which clearly did not correspond to any of the overload fractures near the external loading points. In order to reduce the sample activity to reasonable instrument threshold values, the piece was cut according to the specific cutting scheme presented in Figs. 1B and 1C. The final cut was performed in parallel to the fracture surface at a distance of about 0.8 mm. The remaining piece was slightly polished from both sides while still preserving the branched IASCC cracks on the fracture surface, see Fig. 2A.

Figure 2: TTO-1-053 FIB specimen preparation from the same primary fracture surface shown in Fig. 1D. (A) Overview of the intergranular fracture surface post cutting operations. (B-E) Backscattered electron (BSE) images of electron-transparent IASCC crack embedded TEM lamellae. (E) FEI's OptiTilt low voltage BSE image demonstrating the leading grain boundary structure. The orientation of compression test autoclave loading unit imposed tensile stress direction is perpendicular towards the lamella surface orientation.

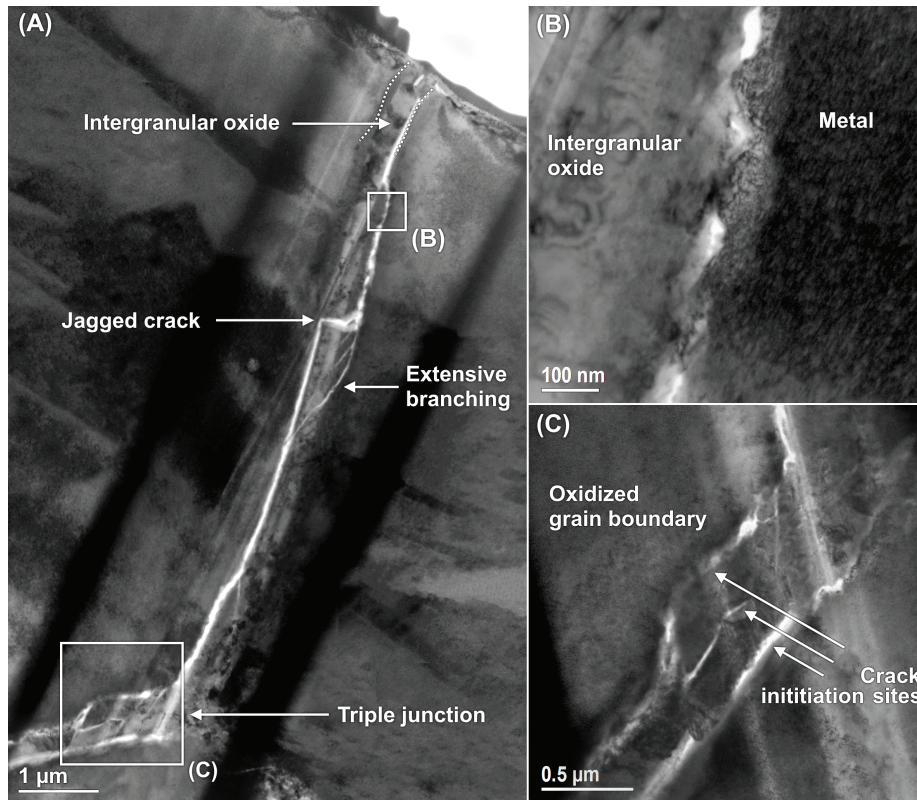
The extent of intergranular oxidation for a typical IASCC crack branch leading up to a grain boundary triple junction is shown in Fig. 3A. The crack path is characterized by an extensive but brittle branching nature and remains fully developed within the intergranular oxide. The crack mainly follows the metal-oxide interface, as demonstrated in Fig. 3B. Presumably, the applied external stress caused the crack to propagate alongside its weakest interface i.e. strained metal-oxygen bonds, which are inherently more chemically active and thus more prone to cracking than non-strained bonds. Additionally, it is important to express the significance of the three-dimensional aspect of the crack morphology. Certain sections of the crack may subside and/or re-emerge within perspective of the lamella. In addition to the straight cracking nature of the interface, which is followed by an often jagged crack path within the intergranular oxide, these signs are interpreted as a form of brittle crack propagation within the intergranular oxide. Fig. 3C emphasizes on the formation of multiple crack initiation sites within the dense oxidized triple junction. Under closer inspection, these initiation sites may nucleate into numerous brittle microcracks which are formed mostly parallel to the main intergranular crack propagation direction. While under the influence of the external load, these microcracks coalesce into the formation of a fully developed crack front. This observation strongly agrees with the global crack morphology of the main branch. It is believed that the formation of microcracks is of importance to the crack initiation process [39].

Figure 3: TTO-1-053 L03 (A) BF-TEM overview of a main IASCC branch leading up to a completely oxidized grain boundary triple junction. (B) Magnified view of the metal-oxide interface cracking. (C) Representation of the strong crack branching nature within the intergranular oxide. The darker contrast bands represent intentionally thicker strokes of material that are left behind during the process of FIB-milling in order to mitigate the strong curtaining effect underneath the oxidized triple junction.

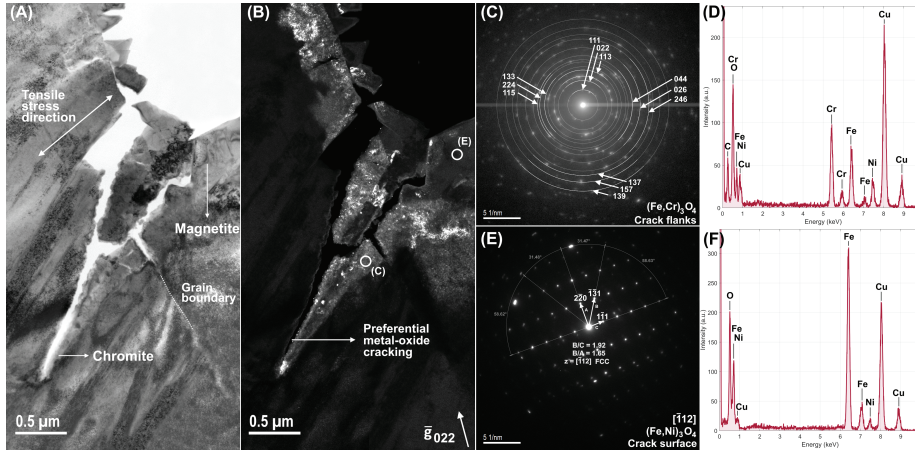
290 Additional demonstration of an IASCC crack propagating along the metal-oxide
 interface is presented in the BF-TEM and DF-TEM overview images presented
 in Figs. 4A-B. From the DF-TEM view of the intergranular oxide, it is again
 apparent that the crack favorably propagates alongside the metal-oxide inter-
 face, leaving one particular side of the crack flank progressively more oxidized
 295 than the other. Its intergranular oxide structure has been examined through
 diffraction- and EDS-analyzes, see Figs. 4C-E. The attained phase structures
 are representative for all other intergranular IASCC cracks assessed in this re-
 search. From the results, it can be concluded that there is a separation between
 two different oxides. The entire oxide assembly is constituted of a primary
 300 nano-grained crystallite chromium-oxide enriched with a strong iron-rich sig-
 nal, and a coarse-grained secondary oxide revealing mainly signals of iron and

Figure 4: TTO-1-053 L06 (A) BF-TEM and (B) DF-TEM of an IASCC crack imaged from an intergranular oxide reflection. Respectively, the (C,E) diffraction patterns and (D,F) EDS spectra of the corresponding chromite spinel $(\text{Fe,Cr})_3\text{O}_4$ and the magnetite deposit $(\text{Fe,Ni})_3\text{O}_4$ oxides are depicted. The strong Cu-signal originates from the TEM grid holder.

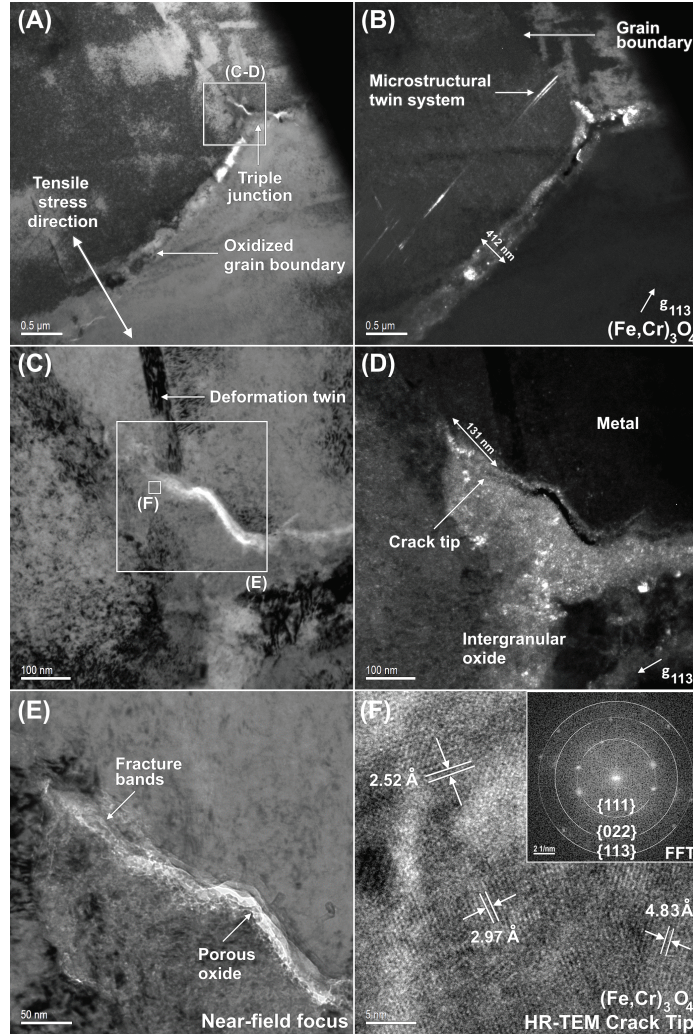
Figure 5: TTO-1-053 L03 (A) BF-TEM imaged IASCC intergranular crack propagating along an oxidized grain boundary, also seen in Fig. 2C. (B) Corresponding DF-TEM from an inner oxide reflection. (C) BF-TEM crack tip extending from the triple junction illustrating the presence of deformation twinning at the crack tip. (D) Corresponding DF-TEM illustrating the extent of intergranular oxide penetration in front of the crack tip. (E) BF-TEM underfocus Fresnel contrast image of the same crack tip from edge-on orientation. (F) HR-TEM of the oxide near the crack tip seen in (C), with a reduced FFT diffractogram as an inset matching the largest d-spacings of the chromite.

IASCC crack tips were either observed extending from beyond branched oxidized triple junctions, or at the end of converged intergranular cracks, see Figs. 5A-B and 6A respectively. Most crack tips showed similar characteristics in

Intergranular oxide penetration in front of the crack tip was consistently observed by performing SAED imaging of the crack tip oxide, see Figs. 5D and 6B. This oxide ingress may span distances of hundreds of nm's in front of the propagating crack tip. Several tips additionally showed porous structures within this leading crack tip oxide. Consequently, further investigation was performed from edge-on orientation using near-field Fresnel contrast imaging. Fig. 5E illustrates the porosity of the intergranular oxide which can be clearly seen adjacent to the crack flanks and leading crack tip edges near the metal interface. In front of the crack tip, noticeable fine fracture bands may be observed that represent the formation of brittle microcracks within the oxide-filled regions. These fracture bands propagate straight to the furthest intergranular oxide tip. HR-TEM examination of the oxide structure in front of the crack tip revealed that the leading crack tip oxide matches the previously found chromite observed along the crack flanks, see Fig. 5F. The inset FFT diffractogram illustrates reflections that match the largest lattice spacings of said chromite along the crack flanks.

nucleate as a consequence of the fine oxide porosity, which can be associated
585 with the microcrack coalescence mechanism. These findings are in good agree-
ment with the so-called subcritical crack propagation (SCP) process proposed
to be relevant for IASCC by Konstantinović [39]. This model is based on the in-
ternal oxidation model [8, 26, 45, 46, 47]. Accordingly, the SCP model describes
590 a slow crack growth under an applied stress well below the critical value for
oxide rupture, which is pre-determined by an intrinsic failure probability of the
intergranular oxide itself and its bonding with the metal interface. Given the
observation of multiple crack initiation sites within the oxide, the underlying
assumption for a failure probability that drives the crack initiation process is
rather conceivable. The failure probability successfully explains the observation
595 of multiscale fracture bands within the oxide, as is displayed in Fig. 5E. Inter-

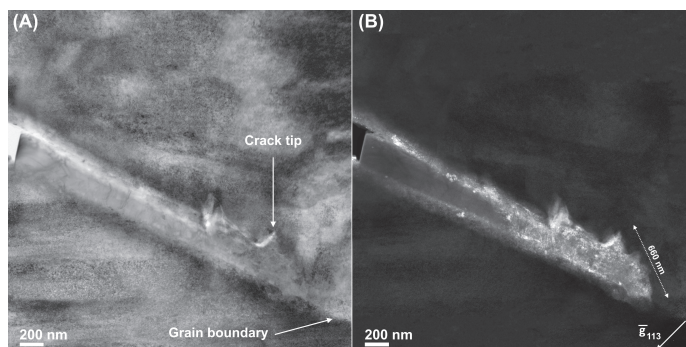
Figure 6: TTO-1-053 L08 (A) BF-TEM, and (B) corresponding DF-TEM of the integral chromite oxide, of an IASCC crack tip propagating along an oxidized grain boundary.

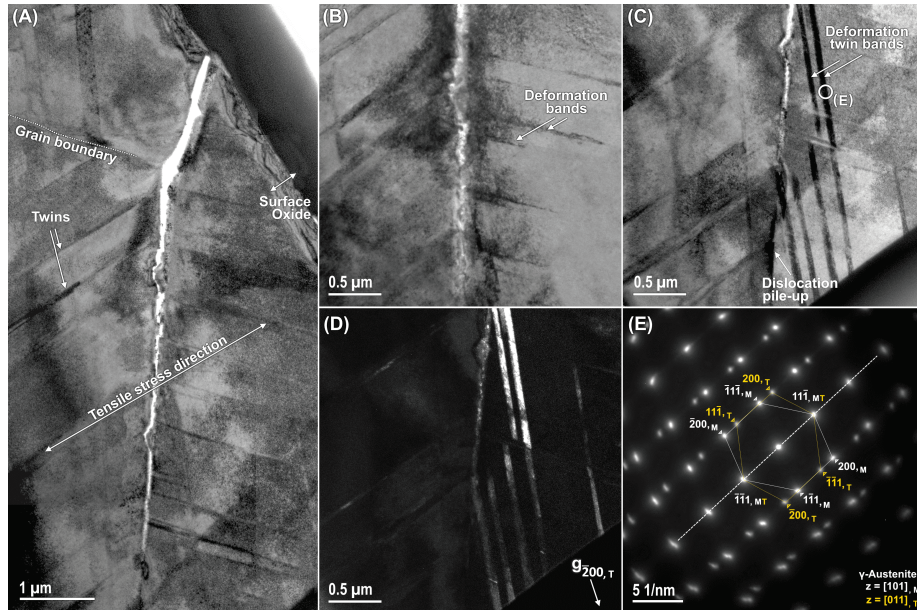
Two representative examples of BF-TEM imaged IASCC cracks are displayed in Figs. 7A and 4A. In analyzing the deformed microstructure, long-running

Figure 7: TTO-1-053 L05 (A) BF-TEM overview of a typical intergranular IASCC crack extending into the bulk. (B,C) BF-TEM deformation structures identified as deformation band and twin bands, respectively. (D) Corresponding DF-TEM, and (E) diffraction pattern of the deformation twin bands.

parallel deformation bands may be observed extending from the crack flanks and tip towards nearing grain boundaries, see Figs. 7B-C. Analysis of these deformation structures was performed through SAED imaging. When tilted into suitable orientation, it was observed that certain bands extending from the crack flanks could not be related to twinning while others that extended from the crack tip typically showed twin-related streak diffraction patterns, see Figs. 7B and 7C-E respectively. Consequently, these deformation structures were identified as general deformation and deformation twin bands accordingly.

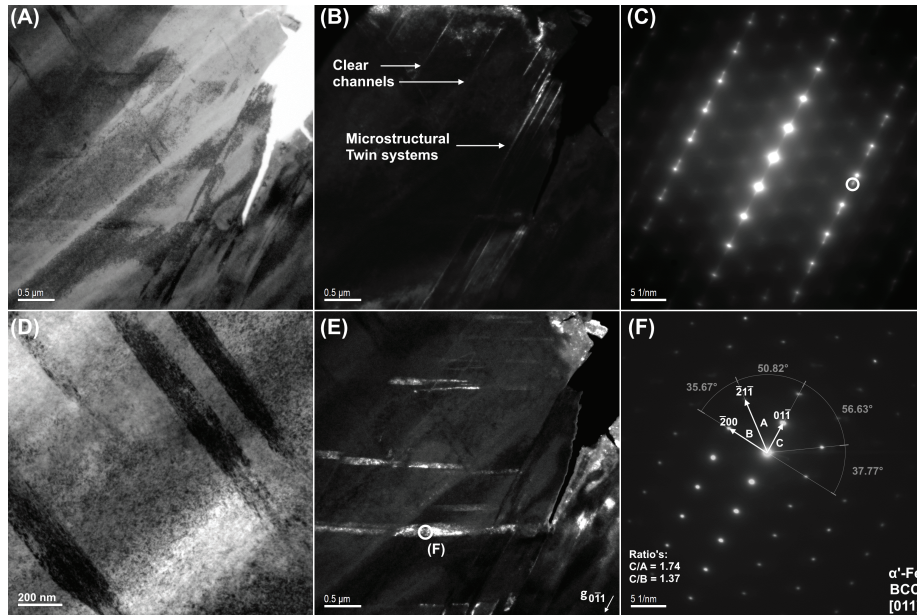
Figure 8: TTO-1-053 L06 (A) BF-TEM overview of the microstructure alongside a crack. (B) DF-TEM of microstructural twins extending from the crack flanks. (C) Corresponding diffraction pattern of twinned structure. (D) Magnified BF-TEM of stress-induced martensitic laths. (E) DF-TEM of laths extending from the crack tip. (F) Corresponding martensitic diffraction pattern illustrating the bcc-nature of the stress-induced α' -martensite from a [011] zone-axis.

Interestingly, aside to typical intergranular crack, notable microstructural defect structures can be observed. On the one hand, Figs. 4A-C depict the formation of microstructural twin systems and their corresponding low-symmetry diffraction pattern. On the other hand, thick deformation laths are occasionally present both within the bulk matrix and extending from the crack tip into the grain interior, see Figs. 8D and 8E-F respectively. Closer inspection of these laths was performed through SAED imaging. Fig. 8F indicates that the thick laths

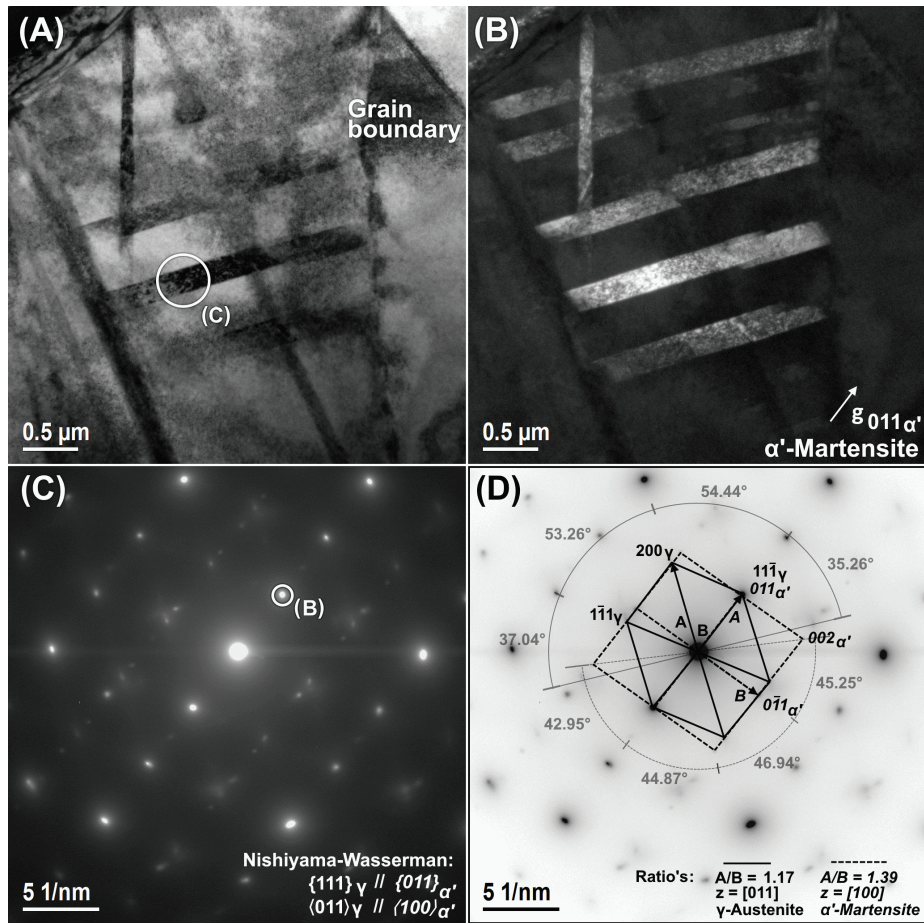
Figure 9: TTO-1-053 L05 (A) BF-TEM and (B) corresponding DF-TEM of martensitic laths extending across the grain close to the crack initiation. (C) Corresponding diffraction pattern of the martensitic laths. (D) Analyzed diffraction pattern matching the Nishiyama-Wasserman orientation relationship between fcc γ -austenite and bcc α' -martensite.

Other instances of martensitic phase transformation are displayed in Figs. 9 and 10. Thick laths are formed across the grain and intersect on either side of the

grain boundary, see Fig. 9A. The following martensitic transformation occurs in close vicinity of the crack initiation point at the specimen surface. Suggested by the darker contrast regions at the grain boundary, dislocation pile-up in-between the intersections of the martensite with the grain boundary is present. The latter may suggest an impeding dislocation motion which may well induce local stress at the grain boundary. The additional reflections that appear in the diffraction pattern illustrated in Fig. 9C closely match the well-known Nishiyama-Wasserman (N-W) orientation relationship [33, 35] between fcc γ -austenite and bcc α' -martensite. Correspondingly, this shows that deformation-induced martensite nucleates along the close-packed crystallographic planes of austenite since both phases appear parallel in the zone-axis diffraction pattern:

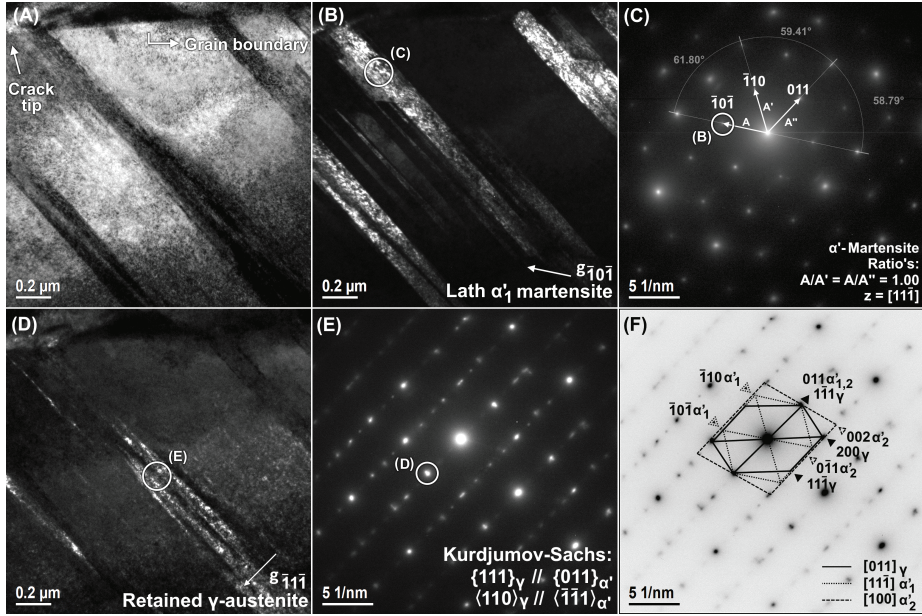
Figure 10: TTO-1-053 L05 (A) BF-TEM and (B,C) corresponding DF-TEM with associated diffraction pattern of α' -martensite extending from the leading grain boundary in $[\bar{1}11]\alpha$ zone-axis orientation. (D,E) Retained γ -austenite located at martensite interfaces with associated diffraction pattern. (F) Analyzed diffraction pattern matching the Kurdjumov-Sachs orientation relationship between fcc γ -austenite and bcc α' -martensite.

Displayed in Fig. 10A-B, similar martensitic lath structures are unmistakably observed extending from the propagating crack tip and leading grain boundary. Once again, the high density of dislocation regions in-between the parent

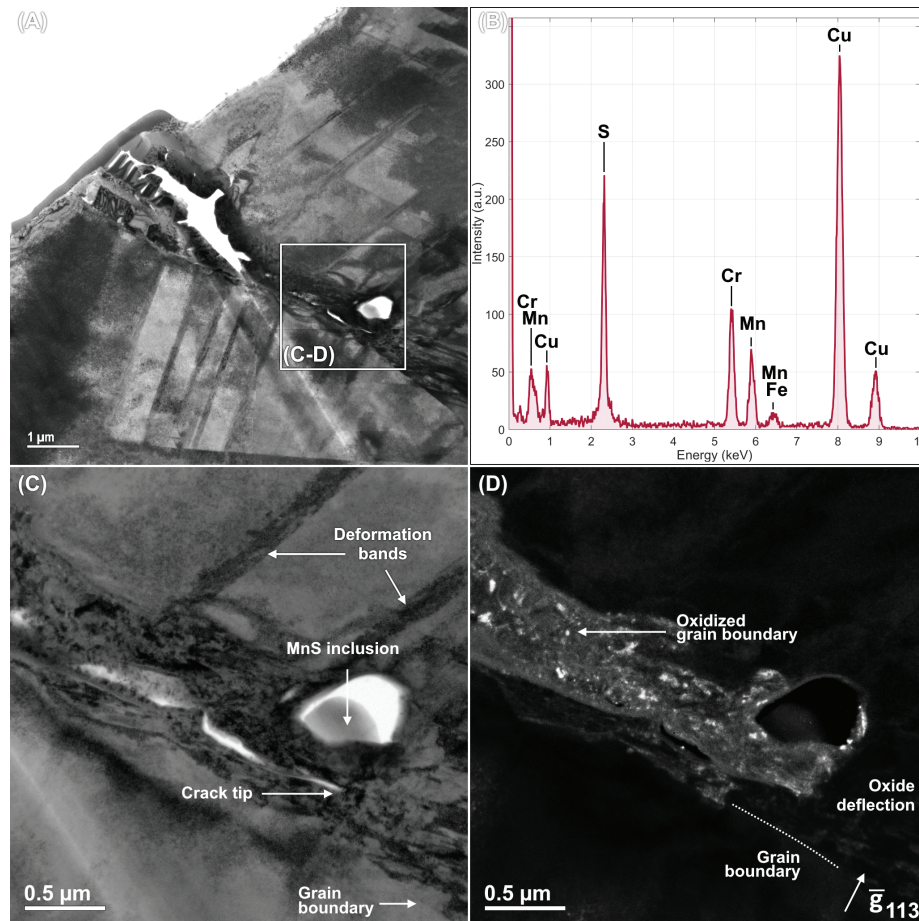
Figure 11: TTO-1-053 L01 (A) BF-TEM of an intergranular IASCC crack arrested at a (B) EDS-confirmed MnS inclusion particle in close vicinity to the grain boundary. (C) BF-TEM of the crack tip illustrating a heavy deformation field in close vicinity to the particle. (D) DF-TEM displaying the intergranular oxide deflection away from the grain boundary towards the inclusion particle.

475 Fig. 11A depicts an overview of an IASCC crack that has clearly arrested at an

intergranular inclusion particle. Close consideration of the chemical structure of the inclusion particle is presented by the corresponding EDS spectrum in Fig. 11B. The spectrum exhibits strong peaks which can be assigned to Mn, S and Cu. As a result, the particle is further referred to as being a MnS inclusion particle, in correspondence to the literature nomenclature [57, 58, 59]. The inclusion particle has segregated close to the grain boundary, altering the crack path and ultimately arresting the IASCC crack. As shown in Figs. 11C-D, it is evident how the oxidation deflects from the leading grain boundary, encapsulating the inclusion. The arrest is accompanied with strong lattice deformation, suggested by the dense deformation field ahead of the crack and the propagation of deformation slip bands from the crack flanks. Interestingly, the intersections of the deformation bands with the crack led to a discontinuous ingress of oxide into the bulk matrix. In association with earlier findings [22, 60, 23], deformation bands may act as fast-diffusion paths for intergranular oxidation. The ingress along the deformation slip bands is reasonably facilitated by the localized dislocation flow in the highly deformed microstructure close to the crack flanks.

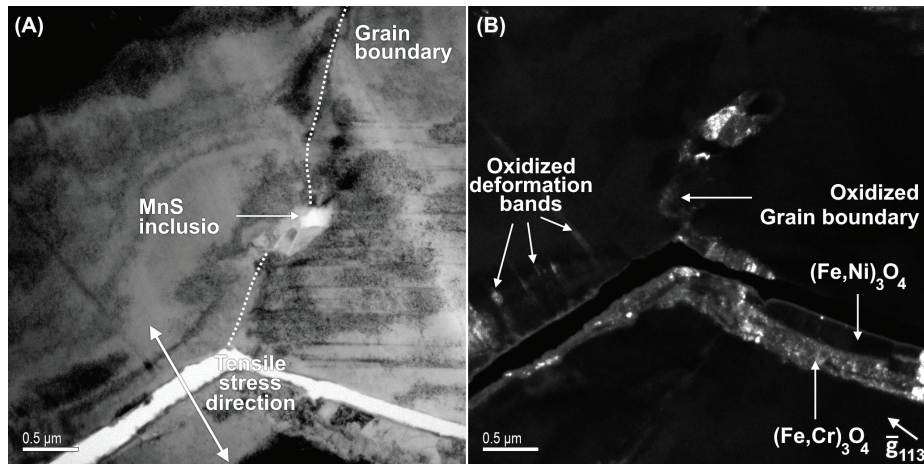
Generally, the role of the external tensile stress with respect to intergranular cracking is made evident under general examination of several fractured grain boundaries. Relative to the orientation of the grain boundary, especially following triple junctions where one of the boundaries failed preferentially compared to the other, it was observed that the cracking typically aligned perpendicular towards the external tensile stress direction. As observed in Fig. 12A-B and

Figure 12: TTO-1-053 L03 (A) BF-TEM of an intergranular crack propagating in cleavage mode in relation to the tensile stress direction. (B) DF-TEM of oxidized grain boundary triple junction. (C-D) DF-TEM of the opposing grains.

Tab. 3, cracks propagating beyond an oxidized triple junction tend to always follow a crack path in cleavage mode orientation, even though the adverse grain boundary was equally oxidized. In agreement with previous studies associating the tensile stress to crack propagation [51], this result indicates external tensile stress assists intergranular cracking most effectively whenever both the grain boundary normal and the stress orientation are aligned in parallel. In all other cases, the crack propagation was shortly followed by a full crack arrest.

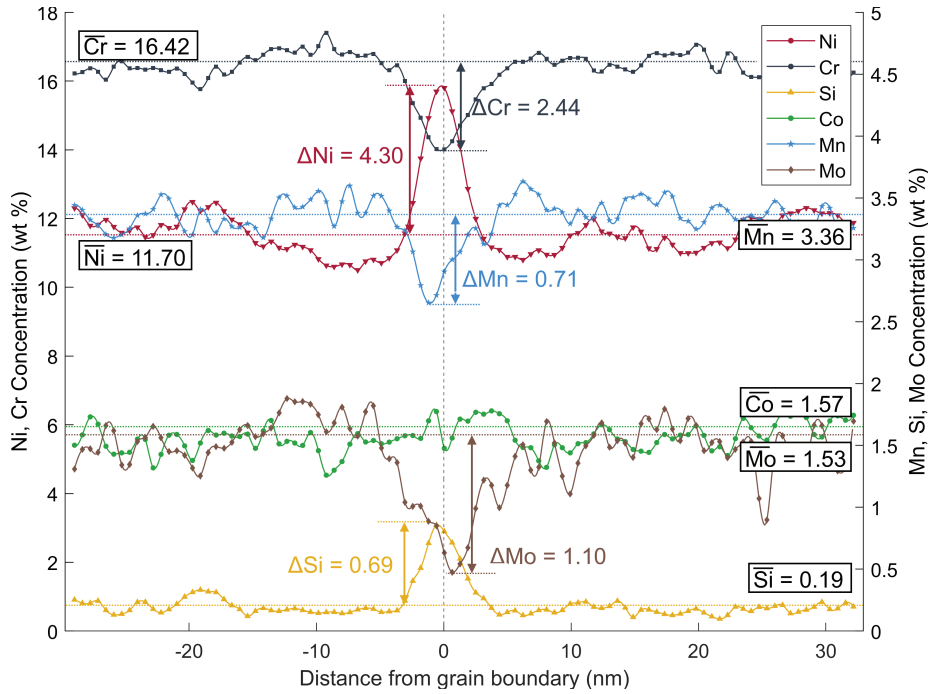
Figure 13: TTO-1-053 L08 HAADF-STEM EDX line scan of edge-on unimpaired grain boundary triple junction.

555 major role for crack initiation. With respect to the role of Si, which was found to be enriched up to five times along the current grain boundary, its implication on crack initiation is not yet fully understood [13].
 560

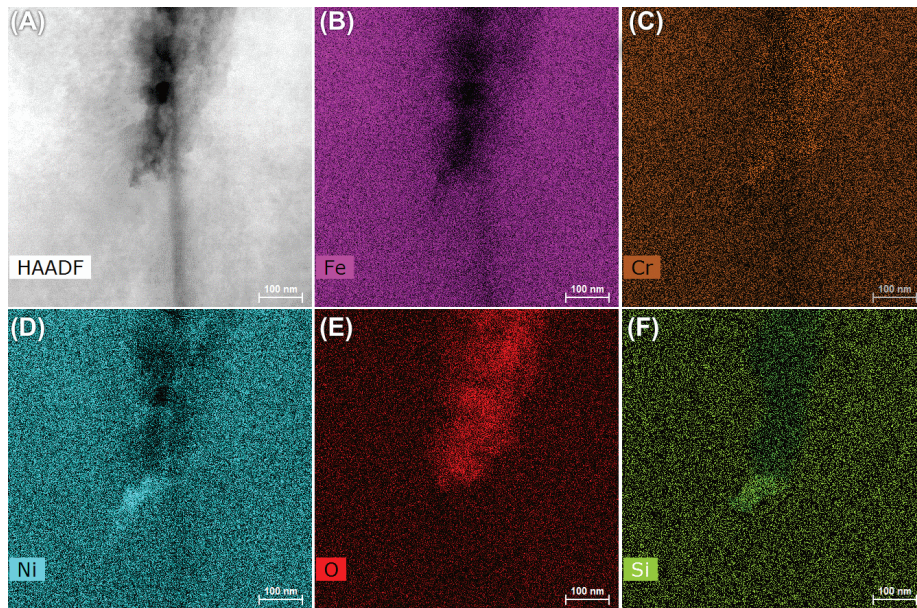
Figure 14: TTO-1-053 L08 HAADF-STEM EDS chemical mapping of enriched and depleted elements close to a selected IASCC crack tip.

Fig. 14 demonstrates the most relevant STEM-EDS maps of an impaired GB
branching from a main IASCC crack. A highly Ni-enriched metallic zone on one
specific side of the grain boundary was observed, spanning a range of approxi-
575 mately 70 nm wide and 75 nm in front of the crack tip. Additionally, preferential
segregation of solute elements such as Si is apparent close to the crack tip. In
that respect, the element composition of the leading grain boundary in front of
the crack tip is expected to be highly altered.
