Article

IR Reflectography and Active Thermography on Artworks: The Added Value of the 1.5–3 μm Band

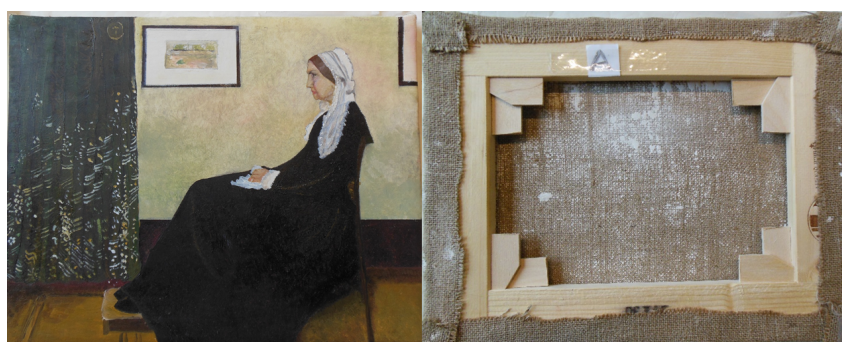
Figure 4. Canvas A with the replica of James Abbott Whistler. On the left is a photograph of the figure (recto) and on the right is a picture of the canvas structure (verso).

James Abbott McNeill Whistler reproductions Both canvas prototypes are composed of hybrid textile supports with different textile fibres. The original painting techniques are reproduced of the original artwork produced by James Abbott McNeill Whistler in 1871, entitled *Portrait of the Painter's Mother* [20]. The main goal for these reproductions is focused on the identification of the canvas structure and to compare the painting strokes. The dimensions of the specimens are $24 \text{ cm} \times 30 \text{ cm}$. The textile support of canvas A was made from hemp and nettle fibres and is shown in Figure 4. This support structure is close to that of the original artwork. While the textile support of canvas B was made from flax and juniper fibres, which is shown in Figure 5. The force used on the paint brush was almost double with respect to the force used in painting A. The method to paint by pressing on the canvas through the paint brush is in contrast to the technique used by the art masters of that time [20].

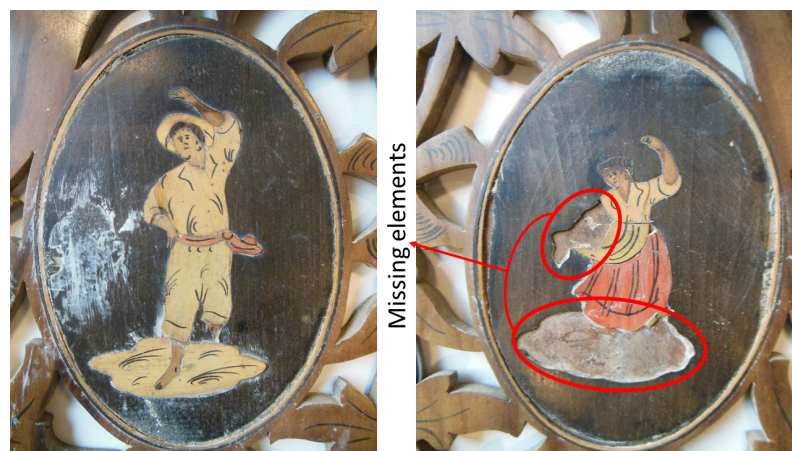
Figure 6. Visual photograph of both marquetry test samples. The right sample contains some surface piercing defects, and the left has only corrected surface piercing anomalies present.

Marquetries These ancient marquetries are originals of Italian origin with multiple subsurface and surface piercing defects and delaminations. The detection of these defects is the main goal for these test samples, independent of grain and wood type used. Both marquetries are shown in Figure 6, where some of the larger defects are visible.

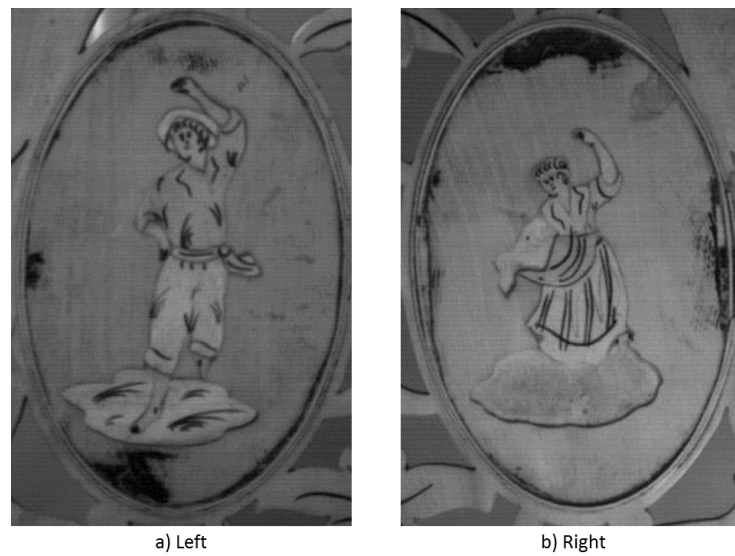
Figure 17. Reflectography results of IR-A camera with halogen illumination.

With respect to the wooden marquetries, in this case, the goal was to inspect both structures on structural integrity. This is performed using IR-A reflectography and active thermography using the IR-C' camera. The reflectography measurements are performed using halogen illumination of 1000 W and the raw results are shown in Figure 17 for both structures. In the visual pictures of Figure 6, it is seen that both marquetries are restored previously; unfortunately, it is not possible to see why. Within the IR-A results, the original defects are prominent visually, which delivers more in-depth information about the reason for restoration. However, no new defect can be found and the applicability is limited.
