Removal of a Past Varnish Treatment from a 19th-Century Belgian Wall Painting by Means of a Solvent-Loaded Double Network Hydrogel

Ehab Al-Emam ^{1,2,*}, Victoria Beltran ², Steven De Meyer ², Gert Nuyts ², Vera Wetemans ³, Karolien De Wael ², Joost Caen ³ and Koen Janssens ²

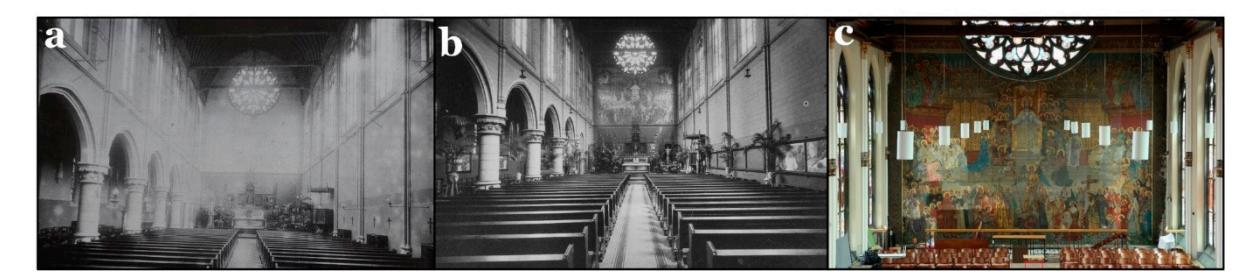
Figure 1. (a) A black and white photograph of the chapel in 1897 in the Sint-Jan Berchmanscollege, when the wall painting was not yet executed. (b) The chapel in the 1930s, after Ernst Wante created the wall painting. The chapel was not yet divided into two floors at that time [33]. (c) A photograph of the wall painting in 2017 showing its state before conservation. The wall painting is now found on the top floor of the chapel.

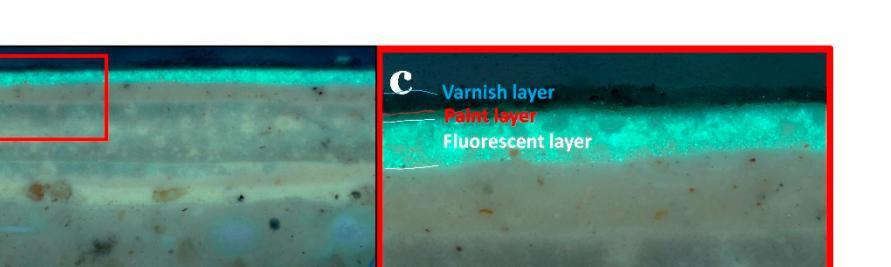
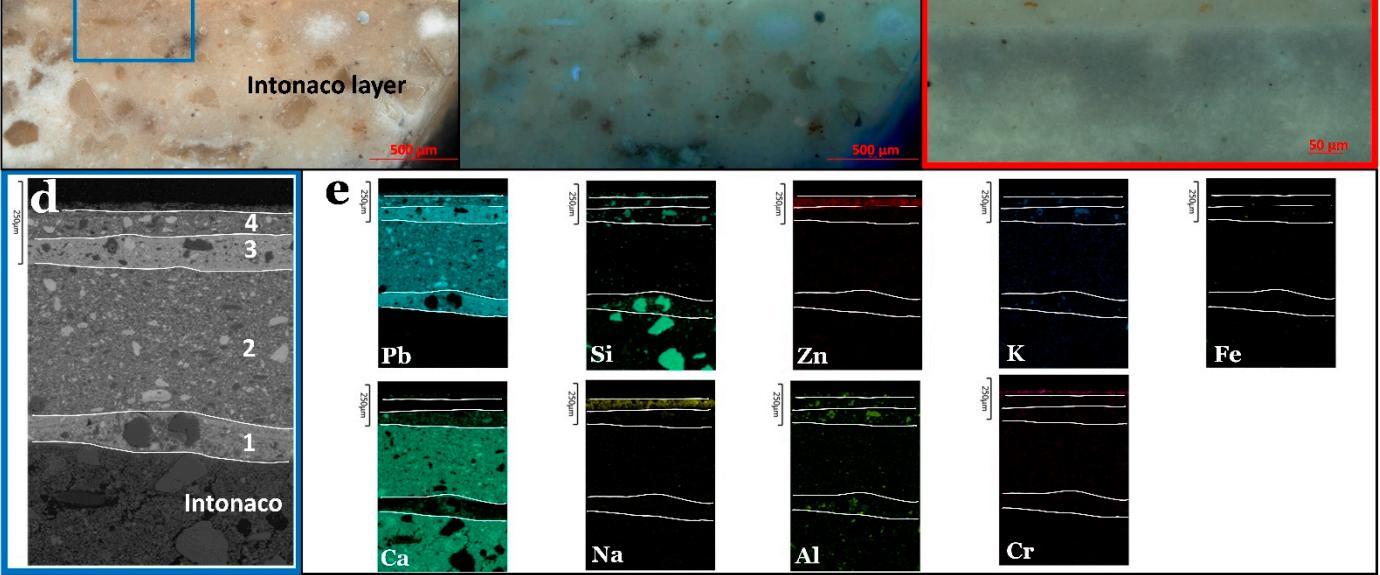
Under the optical microscope, the arriccio layer (thickness: *c*. 10 mm) was characterized by angular/subrounded particles with various sizes ranging from *c*. 50–300 μ m. The color of these particles ranged from dark brown to light brown and yellowish. This layer also contained green and black particles. The use of organic fillers (such as straw and animal hair) is typical in wall paintings [34,35] (see Supplementary Figure S2a,b). The second layer (thickness: 3–7 mm) contained fewer sand particles, and their sizes ranged from *c*. 60 to 450 μ m. It was also characterized by the presence of (organic) fillers, similar to the arriccio layer. The priming coat (thickness: 0.5–0.8 mm) was composed of several layers, which were difficult to differentiate using optical microscopy. This priming coat contains small particles (probably sand). In addition, examination under UV light permitted the identification of a fluorescent top layer underneath the paint layer; see Figure 2a–c. **Priming coat**

Figure 2. (a) An optical microscopy image showing the intonaco, priming, paint layer (black arrow), and varnish layer (red arrow). (b) The same view under UV light. (c) A magnified field of the red rectangular present in 'b'. The image illustrates the fluorescent layer belonging to the priming coat in addition to the paint and the varnish layers. (d) A backscattered SEM image (of the area in the blue rectangle indicated in 'a') revealing the intonaco layer and the superimposed four layers of the priming coat. (e) Elemental maps acquired by SEM–EDX of the same field are presented in 'd'.

In the case of the priming coat (Figure 2d, layers 1, 2, 3, and 4), the backscattered electron image and the elemental maps allowed for better discrimination of the different layers than optical microscopy. It was observed that the priming coat was composed of four superimposed layers, which differ in composition and thickness. The first layer, with a thickness ranging from *c*. 70 to 190 μ m, was rich in Pb, suggesting the use of lead carbonate considering the white color of the layer. In addition, Si was detected as quartz particles in addition to the presence of Al, Ca, K, Fe, and Na in minor amounts. Ca and Pb were present in high concentrations in the second layer (thickness = *c*. 220–450 μ m), which may be attributed to the presence of a mixture of lead carbonate and calcium carbonate. Other elements were also detected in minor quantities, such as Si, Al, K, Na, and Fe. The third layer (thickness = 20–100 μ m) had almost the same elemental distribution as the first, with major proportions of Pb along with the existence of the other elements (Si, Al, Na, Ca, K, and Fe) in minor proportions. The thickness of the fourth layer ranged from 30–120 μ m and was mainly composed of Pb, Zn, and Na. In addition, Al, Si, Ca, K, and Fe were

present. It is worth mentioning that this layer is the one that showed fluorescence under UV light. In addition, the fluorescence that can be seen in Figure 2c was directly correlated with the distribution of the element zinc (Figure 2e), suggesting that zinc oxide is probably responsible for this feature [36].

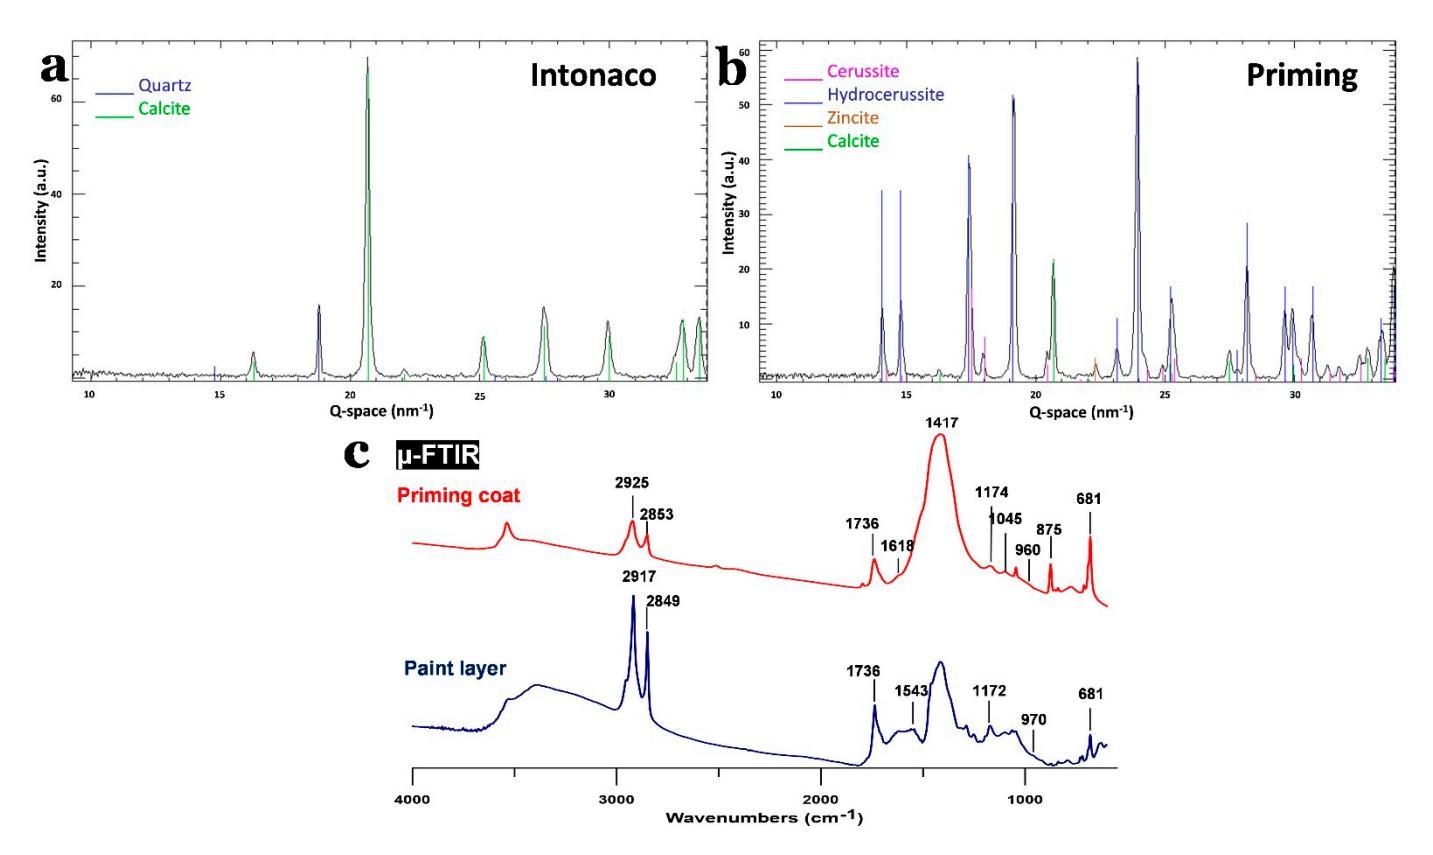
The collected XRD diffractogram from the arriccio layer supports the results acquired from the SEM-EDX. The sample was mainly composed of quartz (SiO₂) and calcite (CaCO₃) (see Supplementary Figure S2d. The intonaco layer showed abundant amounts of quartz and calcite (Figure 3a). The priming coat contained lead white (90% hydrocerussite-Pb₃(CO₃)₂(OH)₂-and 10% cerussite-PbCO₃) in addition to the presence of calcite (Figure 3b), as demonstrated by the SEM-EDX Pb map. This coat also contained zincite (ZnO), as was suspected from the fluorescent fourth layer observed under OM. Small fragments from an unvarnished painting surface and the top layers of the priming coat were extracted and analyzed with μ -FTIR spectroscopy (see Figure 3c). The collected spectra from the paint surface showed bands at 2917 and 2849 cm⁻¹, corresponding to the presence of long CH_2 chains (CH stretching); the peak at 1736 cm⁻¹ was probably related to esters (C=O stretching). These bands can be linked to the presence of wax, drying oil, or a mixture of both compounds; the band at 1172 and the shoulder at 970 cm⁻¹ agree with the presence of drying oil (vibrations of the polymeric chain) [37]. In addition, in the painting layer, there was a band at 1543 $\rm cm^{-1}$, which was related to the presence of carboxylates (C=O stretching), normally related to the reaction products of drying oil and inorganic pigments, which also have sharp bands at 2917 and 2849 cm⁻¹ [38]. However, the sharpness and the high intensity of the bands at 2917 and 2849 cm⁻¹ suggest the presence of a drying oil together with a wax [39]. The presence of wax would also explain the sticky texture of the painting surface.

Regarding the pigments, the characteristic markers of lead white (bands around 1417 and 1045 cm⁻¹, vibration from carbonate moiety) [40] and calcium carbonate (bands around 1430 and 875 cm⁻¹, vibrations from the carbonate moiety) [41] could be seen in the painting layer, which agrees with the results obtained from SEM-EDX and XRD.

The spectra collected from the priming coat also displayed bands at 2925 and 2853 cm⁻¹, together with the bands at 1736, 1174, and 960 cm⁻¹, indicating the presence of a drying oil. Nonetheless, the intensities of these bands were smaller than those in the painting layer, indicating that the proportion was lower. On the other hand, the broader bands at 2925 and 2853 cm⁻¹ compared with the paint layer suggests that wax was present in lower amounts. Similar to the painting layer, a shoulder at 1618 cm⁻¹ was noticed, probably linked to carboxylates. Additionally, there were also lead white and calcium carbonate bands, which agreed with the data collected using SEM-EDX and XRD.

Figure 3. (**a**) and (**b**) XRD diffractogram of the intonaco and priming coat, respectively. (**c**) μ-FTIR spectra of the painting and priming coat.

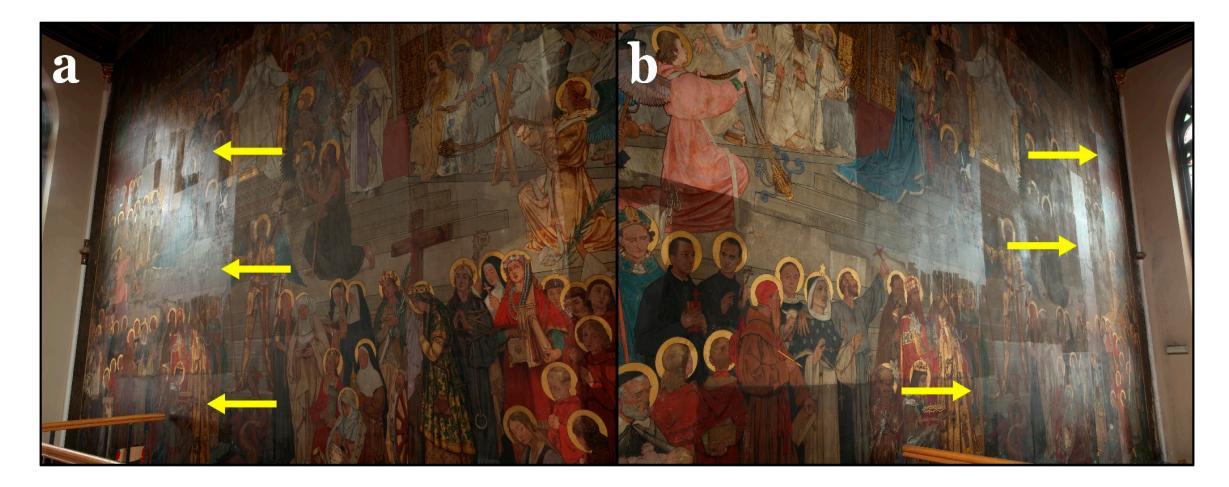
In a previous undocumented conservation campaign, the wall painting was partially coated with a varnish layer, while some areas were left uncoated. Examination of the collected samples under the microscope revealed that the thickness of this layer was in the range of $20-45 \ \mum$ (Figure 2c). The varnish was probably applied to protect the paint layers and facilitate routine cleaning. Nonetheless, the varnish layer has degraded, leading to significant changes in its appearance. The most noticeable change is the severe darkening, obscuring the clarity of the painting's figures and colors. Additionally, the varnish altered the original matt appearance of the wall painting, giving it a glossy surface (Figure 4a,b). Along with the deteriorated varnish layer, the wall painting also showed a number of other manifestations of degradation, such as paint losses, detached paint layers, hollow areas in the plaster layers, surface soiling, and lacunae.

Figure 4. Photographs showing the glossy varnish that was not applied to the entire wall painting, as indicated by the yellow arrows. (a) Left side and (b) right side of the wall painting.

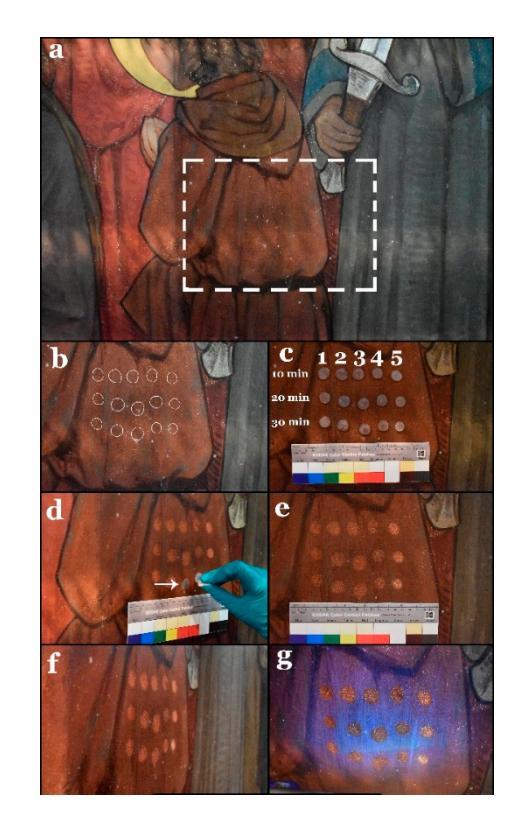
To achieve this, the five hydrogel composites were applied in small hydrogel pellets (with a diameter of *c*. 1.5 cm and a *c*. 0.3 cm thickness) on the wall painting for 10, 20, and 30 min (see Figure 5a–c). After the hydrogel composites were peeled off, the varnish layer was noticeably whitish because of the swelling effect; the pretreated varnish could be rapidly and gently rubbed away by means of a dry cotton ball (see Figure 5d). Visually, the hydrogel composite, loaded with 5/5% MEK/1-PeOH, induced severe damage to the paint layer (see Figure 5e,f). The results of 10% EA, 10% PC, and 5/5% EA/PC hydrogel composite were more or less similar. On the other hand, the 10% MEK hydrogel composite yielded unsatisfactory results: varnish removal was difficult, possibly leaving varnish residues. Regarding the contact times, there were no significant differences among them; thus, during the following test activities, only the shortest exposure time was employed.

Figure 5. (a) General view of the selected area for the first stage tests. (b) Selected spots before the treatment indicated by white circles. (c) The five hydrogel composites applied to the surface during three different contact times: 10, 20, and 30 min. The numbers 1 to 5 represent the hydrogels loaded with 10% EA, 10% PC, 5%/5% EA/PC, 10% MEK, and 5%/5% MEK/1-PeOH, respectively. (d) Treatment of the surface with a dry cotton ball after peeling off the hydrogel pellets. The arrow refers to the swelling of the varnish resulting in a whitish haze. (e) View of the selected area after gel cleaning treatments. (f) View of the same area under raking light. (g) The same view under UV light showing the disappearance of the varnish fluorescence and the severe damage that occurred at the treated spots with the 5%/5% MEK/1-PeOH hydrogel composite (right-most column of test spots).

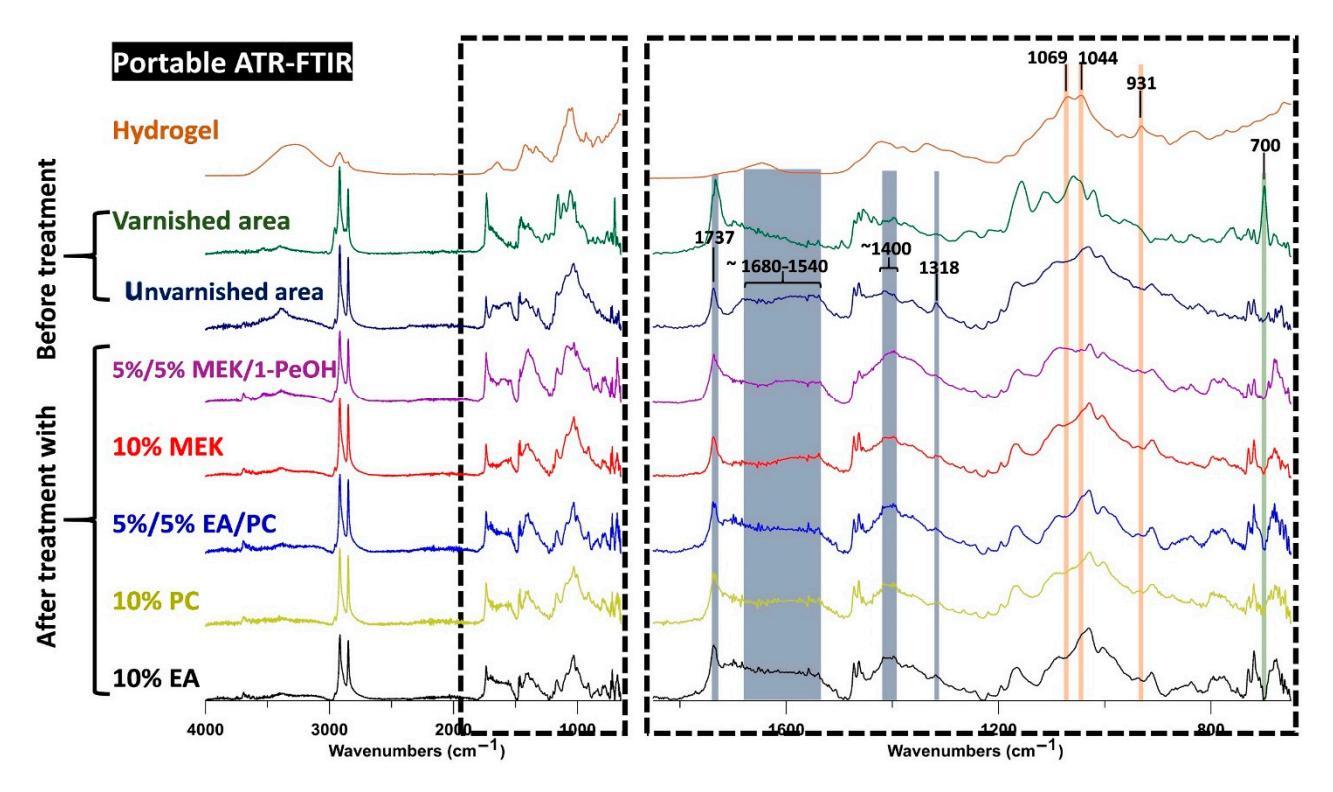
The original painting had bands in the range of 1540 to 1680 cm⁻¹, which were probably linked to the presence of carboxylates (see Figure 6). The intensity of these bands was comparable to the intensity of the band at 1737 cm⁻¹ linked to the use of drying oil as a binding medium. In the spectra of the spot cleaned with MEK, this proportion was different (the band at 1737 cm⁻¹ is higher), probably because of the presence of varnish remains, which have a band at 1726 cm⁻¹ contributing to the enhanced intensity of the band at 1737 cm⁻¹. Additionally, the painting layer showed a band at 1318 cm⁻¹, which most likely corresponds to oxalates resulting from the degradation of the organic compounds and thus was a band that originated from the painting layer. This band was much less intense in the spectra of the region cleaned with MEK, which can be explained by the presence of varnish remains on the surface that partially covered the painting layer. This result is in agreement with the visual examinations.

Figure 6. ATR–FTIR spectra of hydrogel, unvarnished and varnished paint layers, and spots treated with the five tested hydrogels in the first-stage tests.

In the spot treated with 5%/5% MEK/1-PeOH hydrogel composite, some changes were observed around 1400 cm⁻¹. In this spectral range, the unvarnished and the varnished painting had several bands that were probably linked to CH₃ and CH₂ bending. However, in the spectra of the region cleaned with 5%/5% MEK/1-PeOH hydrogel composite, this region showed an intense band corresponding to lead carbonate (1416 cm⁻¹), which was also found in the priming coat. This suggests a partial removal of the painting layer, thereby exposing the preparation so that the associated compounds showed more intense bands. Furthermore, the bands related to carboxylates (bands between 1680 and 1540 cm⁻¹) were lower in intensity, which is consistent with the partial removal of the paint layer.

Finally, the spectra of the spots cleaned with 10% EA, 10% PC, and 5%/5% EA/PC hydrogel composites showed no clear differences compared with those of the unvarnished areas. To confirm these conclusions and select the most suitable hydrogel composites, more tests were performed.

The collected spectra of the treated spots also provided information about the potential presence of hydrogel residues. It is relevant to note that the characteristic intense bands of the hydrogel (at 1069, 1044, and 931 cm⁻¹) were absent in all of the spectra of the treated spots; this indicates that the hydrogel left no (ATR–FTIR-detectable) residues on the surface.

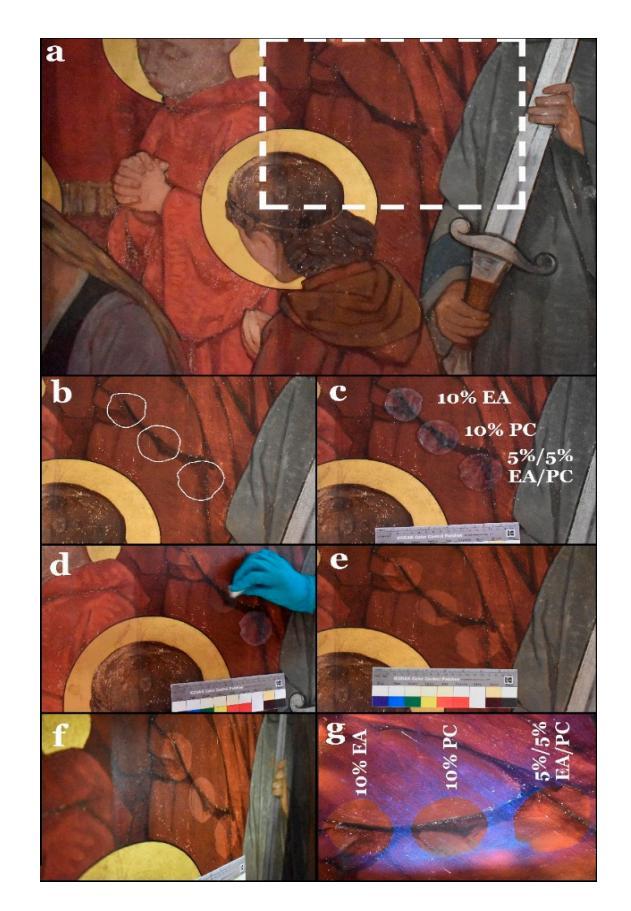
Given the good performance demonstrated by the hydrogels loaded with 10% EA, 10% PC, and 5%/5% EA/PC, these gels were applied to larger areas (with a diameter of *c*. 5 cm and *c*. 0.3 cm thickness) of the same color/paint layer in order to verify the results obtained in the first test (see Figure 7a–d). The gel application time was 10 min.

The effects of the three hydrogel composites were verified by examination of the treated areas under visible and UV light. As in the first stage, there were no differences between the results of the three hydrogel composites (Figure 7e–g); therefore, it was decided to test them on an area of the wall painting featuring a more sensitive paint layer in order to obtain measurable differences in the response.

Figure 7. (a) General view of the selected area for the second-stage tests. (b) Selected areas before gel treatments. (c) The selected three hydrogel composites during application. (d) Removal of the swelled varnish after peeling off the hydrogel using a dry cotton ball. (e) View of the surface after the treatment. (f) The same view under raking light. (g) The same view under UV light.

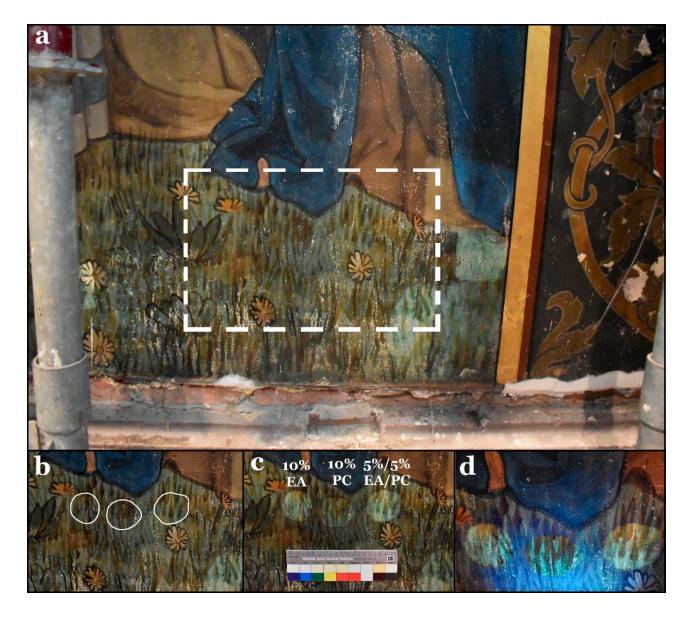
The green/brown areas of the wall painting (representing grass) are composed of superimposed paint layers (see Figure 8a). As can be seen in Supplementary Figure S3b (results of previous varnish removal tests using traditional methods), these areas proved to be very sensitive to any mechanical action. In this regard, the 10% EA, 10% PC, and 5/5% EA/PC hydrogel composites were tested following the same cleaning criteria adopted in the second-stage test. According to the visual examinations, the 10% PC hydrogel composite showed better results than the other two. Both 10% EA and 5%/5% EA/PC hydrogel composites gave rise to a slight overcleaning of the paint layer, which can be explained as a partial removal of the paint layer and the appearance of the white priming coat underneath (Figure 8b–d).

Figure 8. (a) General view of the selected area for the third-stage tests. (b) Selected areas before treatment. (c) The surface after treatment with the three hydrogel composites. Spots treated with the 10% EA and 5%/5% EA/PC hydrogel composites were overcleaned. (d) The same view under UV light showing the same observation regarding the overcleaning effect.

From all the results mentioned above, it can be concluded that the hydrogel loaded with 10% PC provided the best cleaning results overall, especially when treating areas with sensitive paint layers.

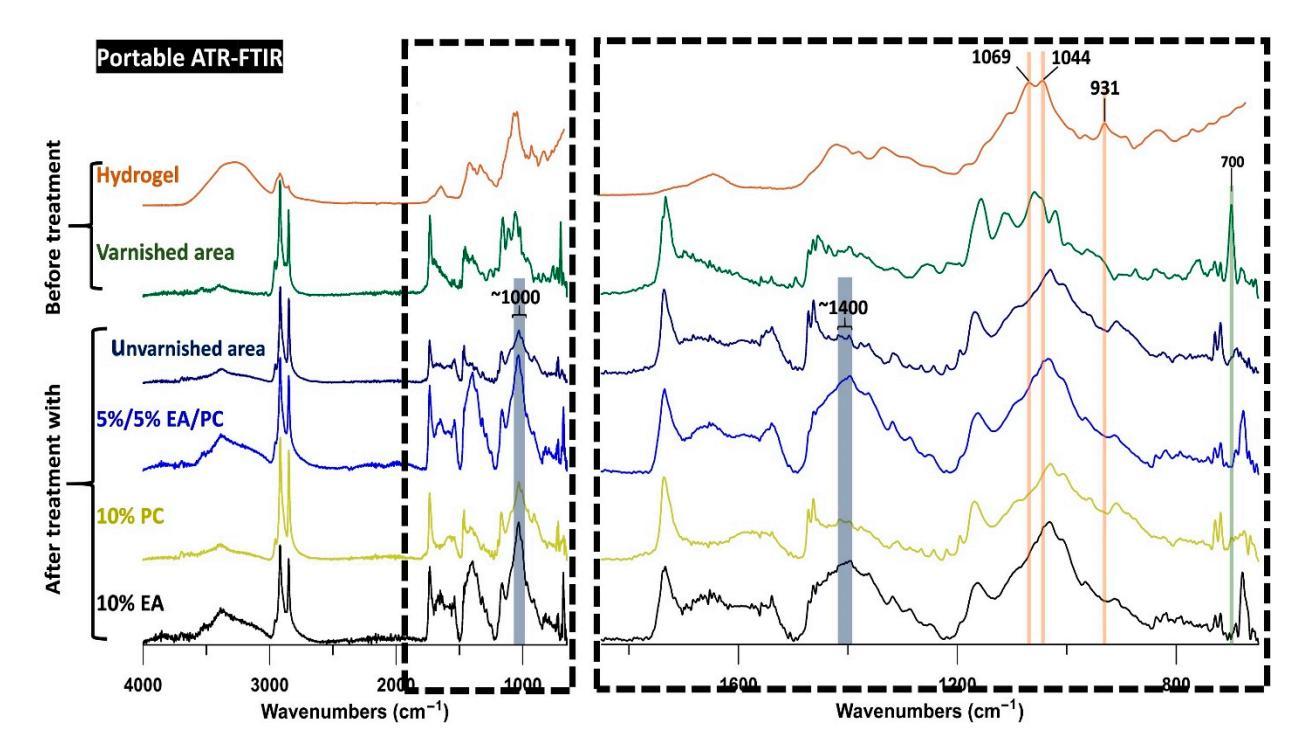
The ATR–FTIR measurements agree with the conclusions obtained from visual examination (see Figure 9). Indeed, spots cleaned with 10% EA and 5%/5% EA/PC showed a more intense band at ~1400 cm⁻¹ related to the lead white present in the priming coat. This suggests that the paint layer was partially removed during cleaning. Additionally, the spot treated with the 10% PC hydrogel composite exhibited more intense bands around 2900 cm⁻¹ that were more intense than the ones assigned to the pigments (around 1000 cm⁻¹); this was likely related to a higher proportion of the binding medium (long CH₂ chains). In the spots cleaned with 10% EA and 5%/5% EA/PC hydrogel composites, the same bands were less intense, indicating that the cleaning process partially removed the binding medium. In general, the spectra of the unvarnished area were very similar to the spectra of the areas cleaned with the 10% PC hydrogel composite, consistent with a small alteration of the painting layer after cleaning. Similar to the results obtained from the first test, the hydrogel did not leave ATR– FTIR-detectable residues on the treated spots.

Figure 9. ATR–FTIR spectra of hydrogel, unvarnished and varnished areas, and the spots treated with three hydrogel composites (5%/5% EA/PC, 10% PC, and 10% EA) in the third-stage tests.

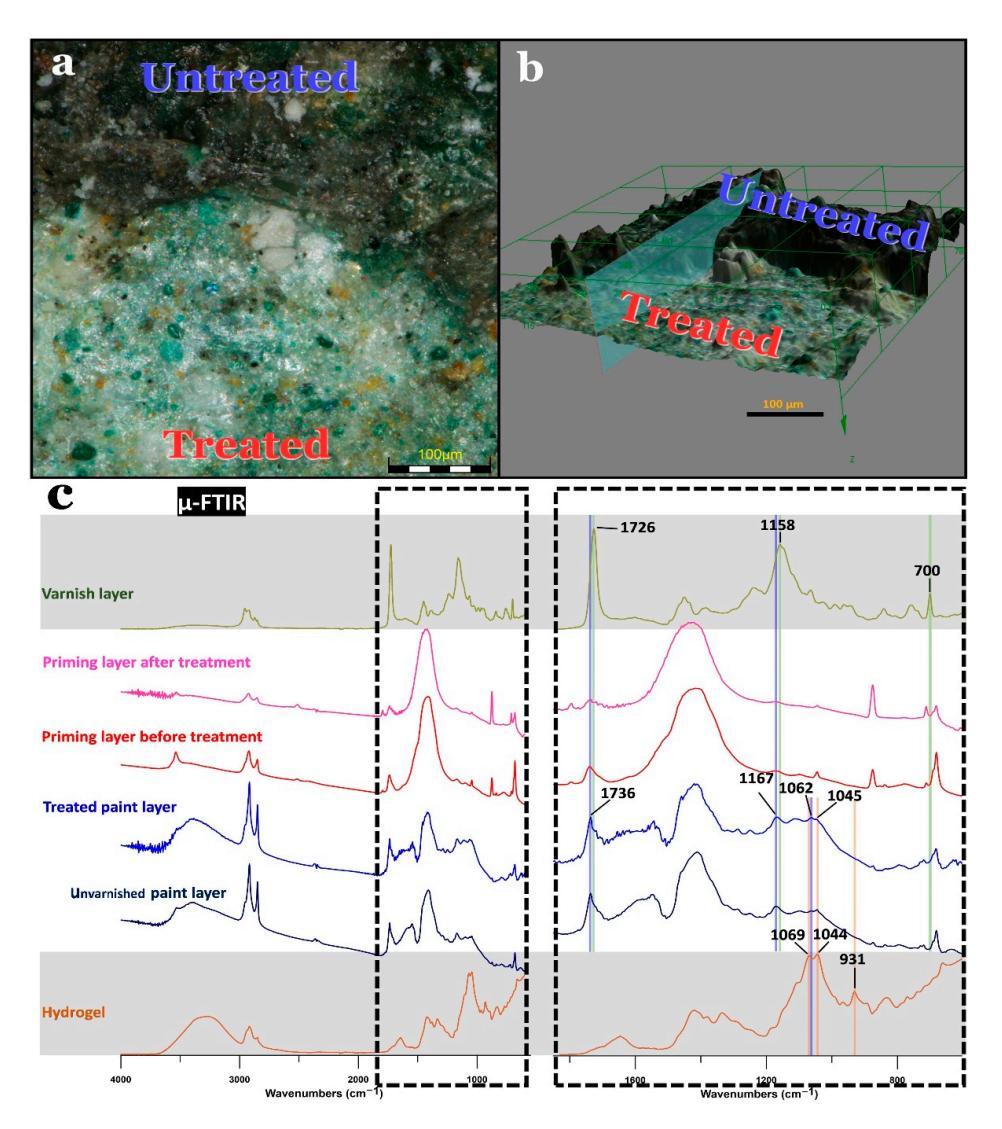
To study the removal of the varnish, a paint sample at the boundary between a gel-treated and an untreated green area was collected and subjected to a number of measurements (Figure 10). Examination of the sample under the three-dimensional microscope showed the darkened varnish layer obscuring the green paint layer in the untreated area. On the other hand, the treated area of the sample showed that the varnish was completely removed and revealed the original appearance of the paint layer, with no hydrogel residues visible (Figure 10a,b).

In order to assess the effects of the gel treatment on the binding medium, fragments from treated and untreated paint areas were collected and analyzed by μ-FTIR spectroscopy. It was noticeable that the spectra of the unvarnished and treated paint layers were very similar (Figure 10c). This indicates that the solvent used for varnish removal caused no changes detected by FTIR. With respect to varnish removal efficiency, the most intense bands of the varnish at 1726 and 1158 $\rm cm^{-1}$ were in a similar position to the bands at 1736 and 1167 $\rm cm^{-1}$ of the drying oil (Figure 10c). An increase in these bands after the cleaning could be attributed to the infiltration of the varnish. There was an additional less intense peak of the styrene component of the varnish at 700 $\rm cm^{-1}$ that did not overlap with any bands from the paint, allowing it to be used as corroboration. As can be seen, after the cleaning there was no increase in the bands related to the varnish. This means that the varnish was successfully removed from the paint layer; if any varnish remained, it was in an amount low enough not to be detected by μ -FTIR. Furthermore, fragments from the priming coat were measured to investigate the infiltration of the varnish into the substrate after gel cleaning. Similar to the paint layer, there was no increase in the bands related to the varnish itself; this confirms that the varnish did not diffuse into the bulk of the paint strata during or after the treatment.

Regarding hydrogel residues investigations, the band at 931 cm⁻¹ was only present in the hydrogel and can be used to corroborate the results. Both the paint layer and hydrogel contain a double band around 1050 cm⁻¹ (Figure 10c). Specifically, the gel showed two peaks at 1044 and 1069 cm⁻¹, while in the paint layer they appeared at 1045 and 1062 cm⁻¹. These peaks were more intense in the hydrogel, so an increase in these bands after the cleaning would be linked to the remains of hydrogel on the surface. However, the band at 931 cm⁻¹ was not present in the painting after the cleaning. In addition, no increase could be seen in the bands at 1069 and 1044 cm⁻¹ after the cleaning. The slight shift of the band at 1062 cm⁻¹ from the painting compared with the band at 1069 cm⁻¹ from the hydrogel could still be seen in the spectra after the treatment, proving that the band at 1069 cm⁻¹ had no significant increase (Supplementary Figure S6). Thus, it can be concluded that there were no μ -FTIR-detectable remains of the hydrogel. Finally, the best cleaning method, i.e. the gel composite loaded with 10% PC, was used to remove the varnish layer on a larger scale.

Figure 10. (a) Photomicrograph showing the boundary between a treated and an untreated area of a green area of the wall painting. The untreated area shows the darkened varnish layer, while the treated area illustrates the total removal of the varnish layer, revealing the original color of the surface. (b) 3D photomicrograph of the same view revealing the presence of a thick, darkened varnish layer. (c) μ -FTIR spectra of the varnish, priming coat before and after the treatment, treated and nontreated paint layers, and hydrogel.

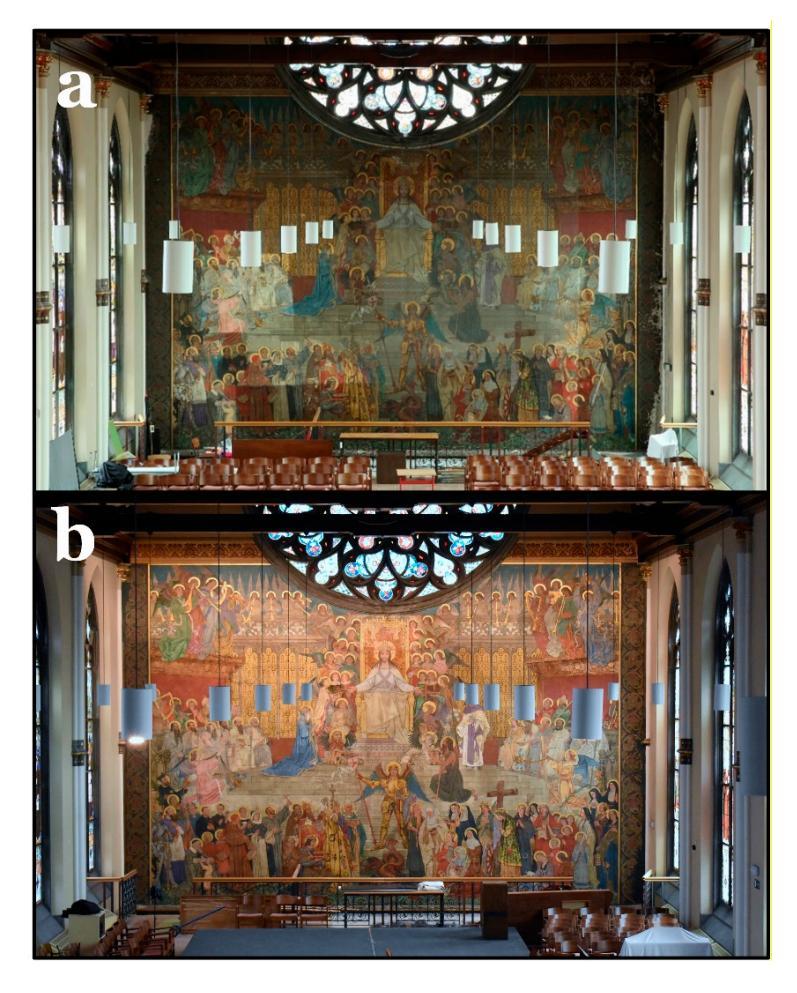
The final results of the conservation of the wall painting are presented in Figure 11. It can be seen that the dark veil caused by the deteriorated varnish could be completely removed, revealing the original colors of the wall painting. The gilded parts now show a shiny appearance again that was previously masked by the varnish. On the other hand, in the non-gilded areas, the original overall matt appearance of the wall painting could be restored.

Figure 11. (**a**) The wall painting during the initial steps of conservation. (**b**) Final results of the wall painting after conservation and removal of the dark varnish layer.
